CAMP SALMEN Technical Guidelines for Reconstruction

CONDITIONS AND RECCOMENDED ACTION

BY: TULANE UNIVERSITY

MASTER OF PRESERVATION STUDIES

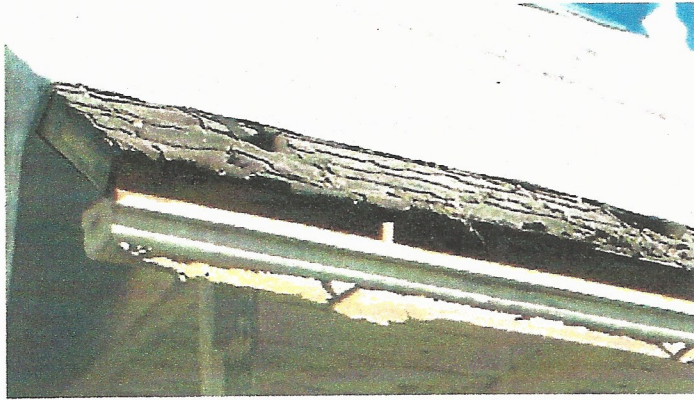
Asphalt shingles have deteriorated and are no longer preventing water from permeating the roof substrate.

- The asphalt shingles shall not be replaced in-kind. Instead an aluminum standing seam metal roof shall be installed with underlayment and drip edges.
- Repoint open mortar joints in the chimney stack with a lime-based, compatible mortar
- Install flashing at the chimney stack-roof juncture
- Replace fascia, rake, and soffit where rot or water damage is evident and repaint
- Replace existing roof decking where rot is evident with compatible wood type and reinforce roof substrate with sheathing layer nailed in line with the existing joists

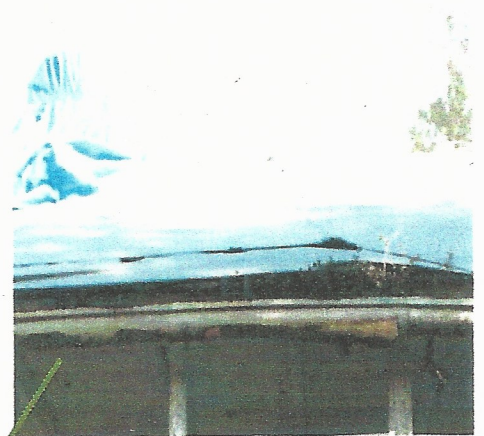
Bio-growth at the eave is indicative of water intrusion and resulting impairment of the substrate.

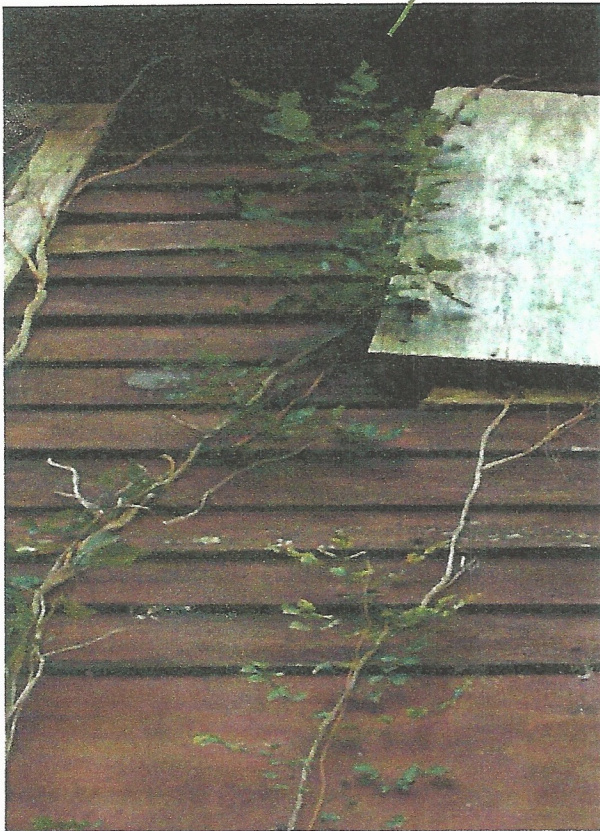
Vegetation growing on house

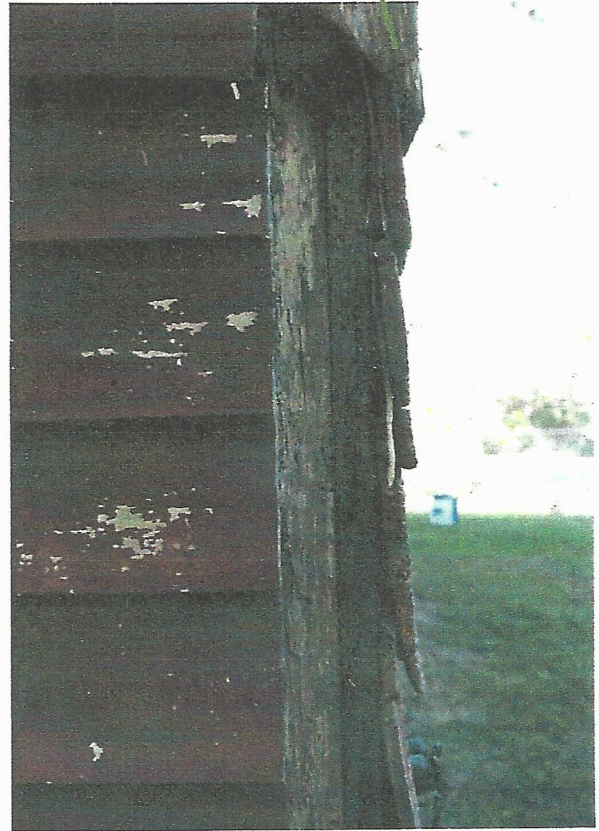
Missing trim at corner

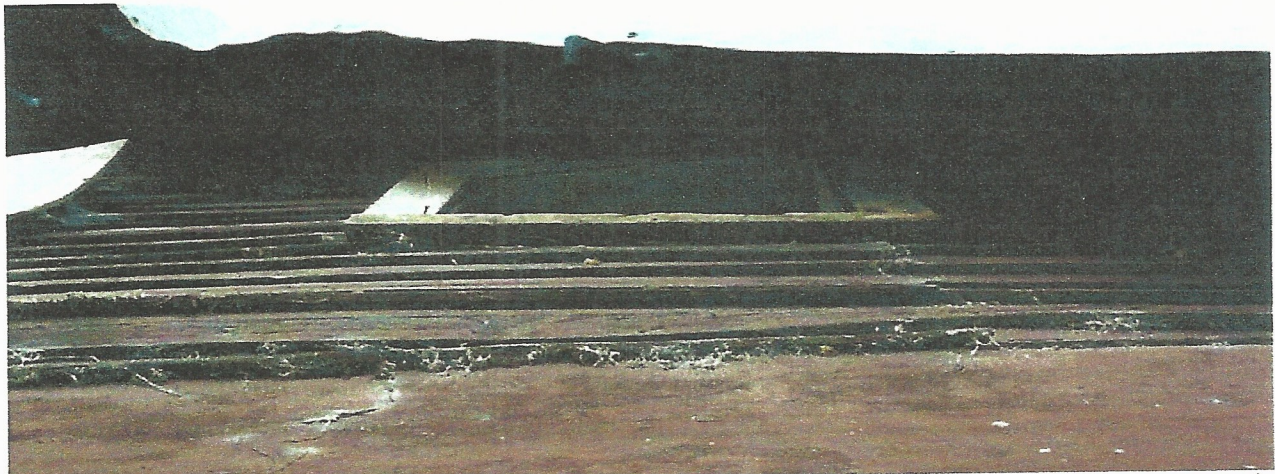
Weatherboards not secured tightly to wall framing

Weatherboard Siding	Loose, cracked, or missing wood siding	Clean surface. Remove damaged weather boards and replace with in-kind materials as needed to enclose building envelope. Check for loose boards and secure with stainless steel ring shank nails. Start replacement siding from the bottom and work up towards the roof, matching the existing reveal. Stagger seams or where possible use full length boards.
	Paint deterioration	Clean properly and remove loose paint surfaces as noted in general recommendations. Prime and repaint with appropriate color as recommended by design guidelines.
	Vines growing on the exterior	Remove vines, which typically trap moisture in woodwork by block sunlight and air circulation. Vines typically follow moisture. Water issues may be perpetuated by the condition of the roof. Once roof is replaced, reassess vegetation growth.
Trim	Missing	Replace missing trim at back corners w/ in-kind materials as needed. Windows covered with plywood- unable to determine current condition. Verify existence and condition of window trim when plywood removed. Repair or Replace deteriorated areas as needed.

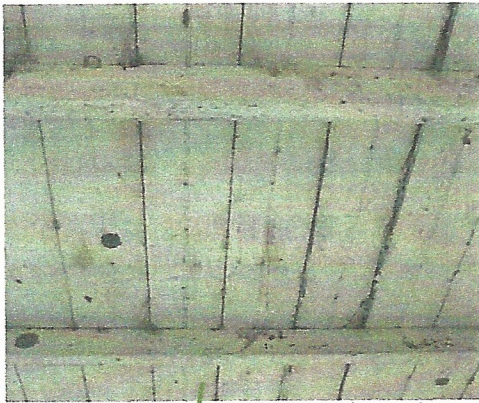
Porch Ceiling- Bead board intact

Porch Ceiling	Beadboard wood- no covers for attic access, paint in fair condition (no peeling)	Measure the two openings and build attic access cover out to inclose building envelope. Material should be beadboard. Hatch constructed with hinges to be opened and closed as needed provide access to the attic space .Repaint ceiling.
Porch Ceiling Beams	Appear to be in good condition	Repaint beams with high quality paint appropriate for the wood substrate in accordance with the manufacturer's recommendations.
Porch Post	6 Chamfered posts with mortise and tenon joints. One open mortise where a posts has been replaced. Some base rot and peeling paint	Replace all exiting posts with pressure treated chamfered post to match the original post. Posts shall be installed symmetrically across the front
Porch Joist	Overall appear to be in good condition. May need minor replacement or sintering to ensure stability.	Further assessment of condition of joist may be necessary to determine replacement. Joist should be solid enough to secure porch post, porch floor and apron. If replacement is necessary, replace with in-kind treated material.

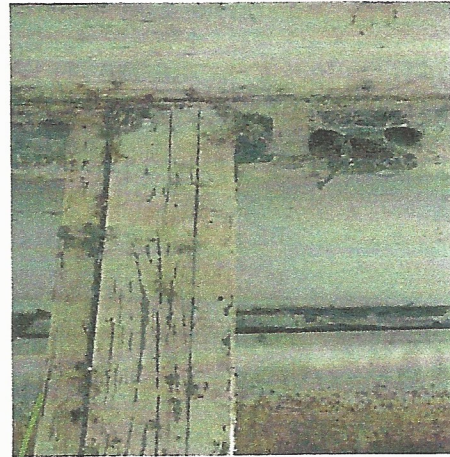
Porch Post- Chamfered posts with mortise and tenon joints. An open mortise where one of the posts has been replaced improperly

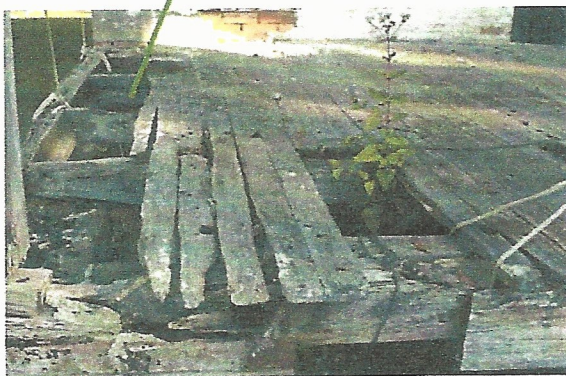
Porch Floor- Rotted and missing tongue and groove boards.

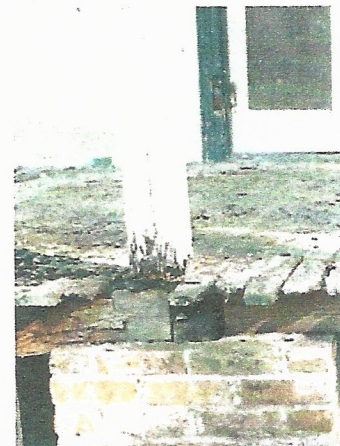
Porch Post- Rotted base

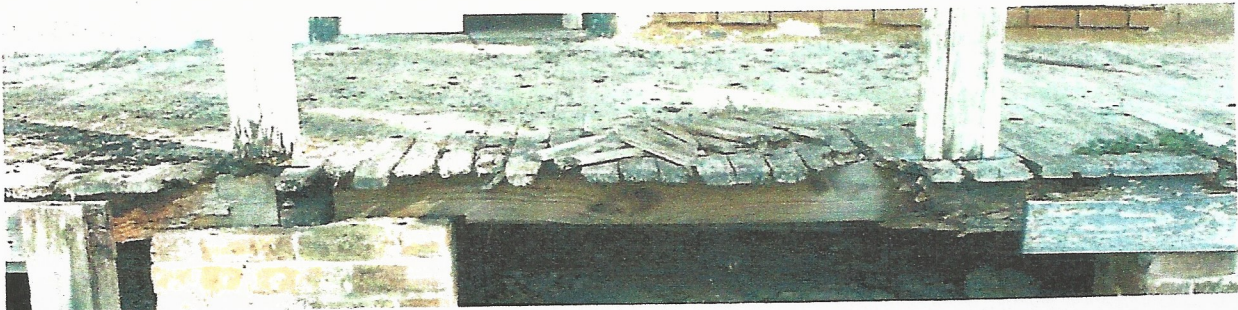
Apron- rotted and missing

Balustrade	Non-existent	Install stainless steel cable rails around porch and on new front steps to meet current IBC requirements.
Apron	Typical wood- water damaged, rot, missing elements	Replace entire apron w/ in-kind pressure treated 1x wooden material. Paint with appropriate paint as described above.
Porch Floor	Typical tongue-and-groove wood boards. Wood rot in sections.	Ensure structural components of porch are either replaced or in good condition before securing new floor boards. Verify porch slope. Replace rotted boards w/ in kind material. Repaint floor as described above.
Porch Steps	Missing	Rebuild our of treated wood according to design documents to meet current IBC requirements.

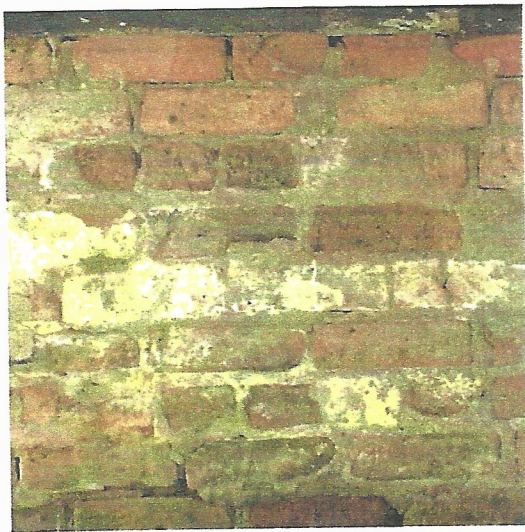
The Portland cement has proven to be detrimental. It has caused water to become trapped forcing a separation of stucco from the brick walls. There are numerous places where stucco loss has occurred to such an extent that the brick is entirely exposed. The exposure of the brick also reveals the mortar loss that has occurred.

Portland cement mortar

In order for the site to move forward, any places where the brick is exposed should see a removal of previous portland cement and lime mortars. A 4-inch blade should be used to remove the mortars. However, if the mortar does not come off easily, it should not be forced to prevent further damage to the brick walls. Hydraulic lime mortar 2 should be used for repointing. A breathable stucco should be placed onto the exposed brick to prevent further brick damage. In places where the Portland cement remains in place, it should not be removed due to the damage that could be caused by the removal process.

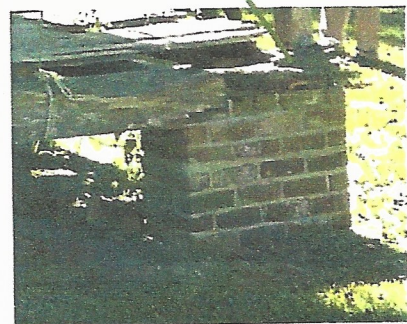
BRICK FOUNDATIONAL PIER

Foundation Piers	Brick piers appear to be in decent condition. Some mortar loss.	The mortar of the foundation piers should be re-pointed in the same manner as the exterior walls.

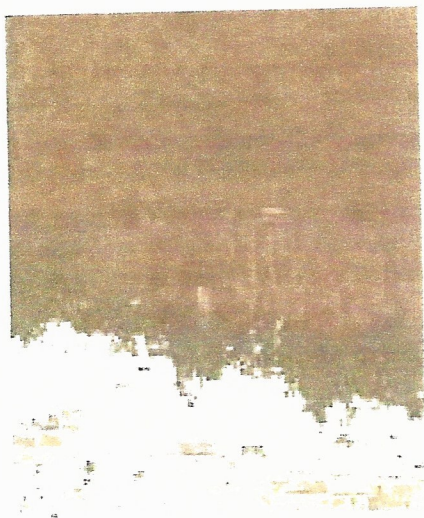
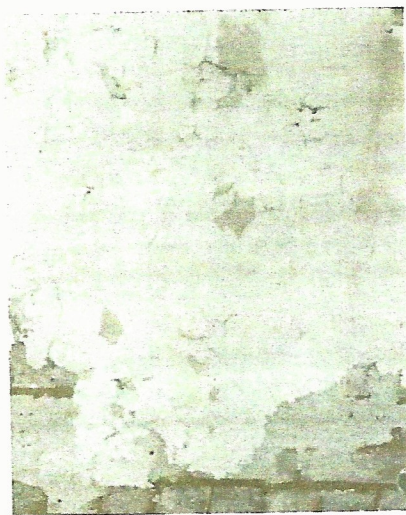
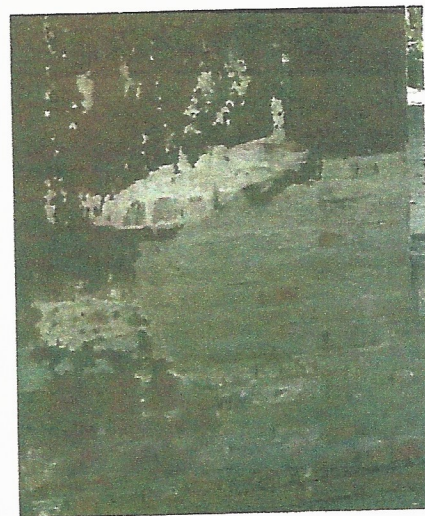
MATERIALS	CURRENT CONDITION OBSERVATIONS	RECOMMENDATIONS
Exterior Masonry Walls	Appears to be decent condition structurally. Delamination of stucco due to trapping of moisture behind a layer of portland cement, which has caused loss of stucco and paint, exposing brick in numerous placesr. Mortar has also degsinigrated.	Where brick is exposed, the portland cement and lime mortars should be removed using a grinder wiht a 4-inch blade. Do no force the removal of any Portland cement, at risk of futher damaging the bricks. The brick should be repointed with hyrdrolic lime mortar two. Carfully remove any delaminating stucco and surface exiting stucco and bricks with new base coat followed by stucco.
Foundation	Brick foundation, appears to be in good condition, some mortar loss, some biogrowth, spider webs	The mortar of the foundation should be repointed in the same manner as the exterior walls. The foundation should also be carefully cleaned to remove biogrowth and spiderwebs.

PAINT AND STUCCO LOSS

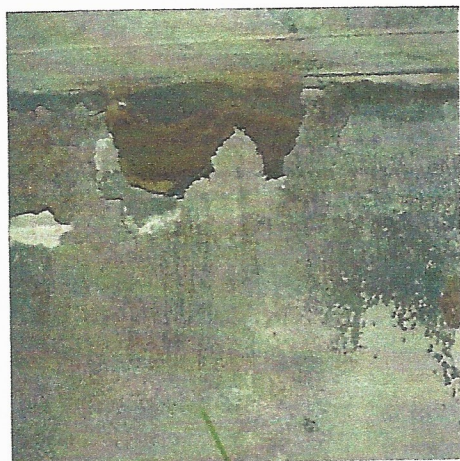
Main Room Plaster

Main Room: The plaster is cracked on the north wall adjacent to the attic and chimney as well as on the south wall in line with the window. In some places the plaster is lost and exposing the brick between post wall structure. This is seen to the right and the left of the fireplace, with the post exposed on the right and the brick and mortar exposed on the left bottom section between the door and the fireplace. Portland cement was applied just above the baseboard in some sections of the wall which appears to be an effort to patch previous stucco/plaster failure. Kitchen: Much of the stucco is degraded or lost near the baseboards. Where the bricks and mortar are exposed, the mortar, which is a soft, clay based mortar is deteriorating due to rising damp. Side Room: The plaster is cracked and lost in some sections exposing the brick and mortar. The mortar is deteriorating where exposed. Some evidence of portland cement near the baseboards in some areas of the walls where surface plaster has been lost. The plaster is cracking primarily on the walls adjacent to the fireplace, which is similar to the main room.

Stress cracks in the plaster can be repaired by opening the crack slightly with a crack widener and filled with a layer of joint compound and then adhering fiberglass mesh tape to close gap followed by another layer joint compound. Where there are large sections of plaster/stucco missing it will be necessary to repair the holes by filling them in with the appropriate lime/plaster replacement material.

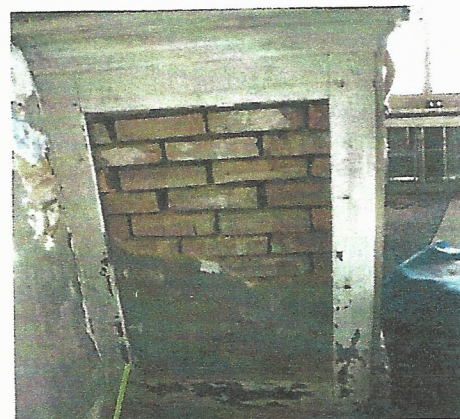
Mortar Deterioration

Some of the plaster is lost and exposing the brick between post. Where exposed, some of the mortar joints are deteriorating.

Identify mortar joints which are deteriorated and need to be repointed. Test mortar for lime/sand/aggregate make-up to identify and replicate hardness and vapor permeability. Remove degraded mortar joints at a depth of at least two times the width of the joint with either hand chisels or an angle grinder. Repoint prepared joints with appropriate mortar which is softer and more vapor permeable than the brick.
