CAMP SALMEN Technical Guidelines for Reconstruction

CONDITIONS AND RECCOMENDED ACTION

BY: TULANE UNIVERSITY

MASTER OF PRESERVATION STUDIES

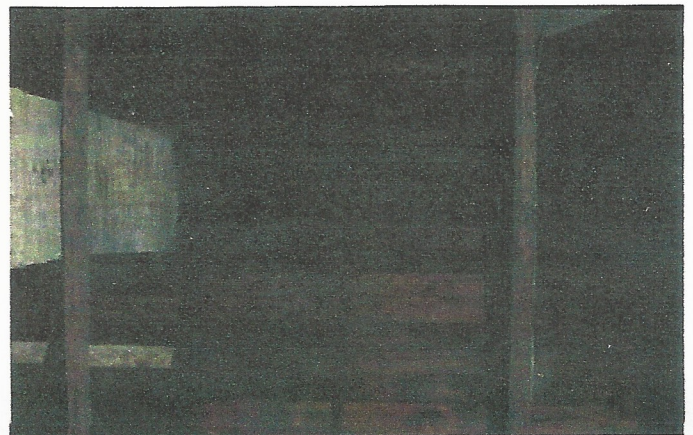
Roof Decking - as seen from the interior - spans the roof horizontally, perpendicular to the joists.

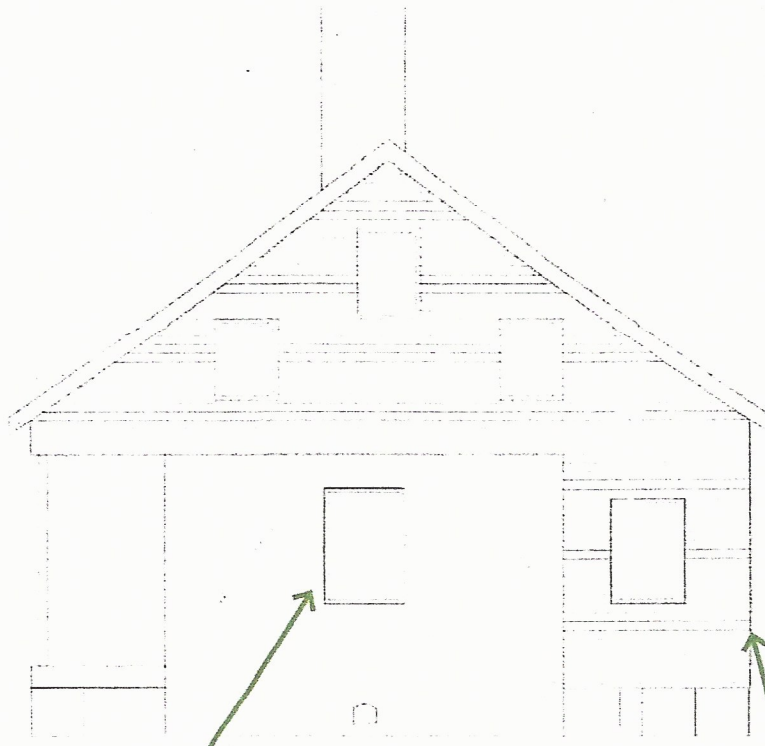
Vegetation growing on house

Weatherboard Siding	Loose, cracked, or missing wood siding	Clean surface. Remove damaged weather boards and replace with in-kind materials as needed to enclose building envelope. Check for loose boards and secure with stainless steel ring shank nails. Start replacement siding from the bottom and work up towards the roof, matching the existing reveal. Stagger seams or where possible use full length boards.
	Paint deterioration	Clean properly and remove loose paint surfaces as noted in general recommendations. Prime and repaint with appropriate color as recommended by design guidelines.
	Vines growing on the exterior	Remove vines, which typically trap moisture in woodwork by block sunlight and air circulation. Vines typically follow moisture. Water issues may be perpetuated by the condition of the roof. Once roof is replaced, reassess vegetation growth.
Trim	Missing	Replace missing trim at back corners w/ in-kind materials as needed. Windows covered with plywood- unable to determine current condition. Verify existence and condition of window trim when plywood removed. Repair or Replace deteriorated areas as needed.

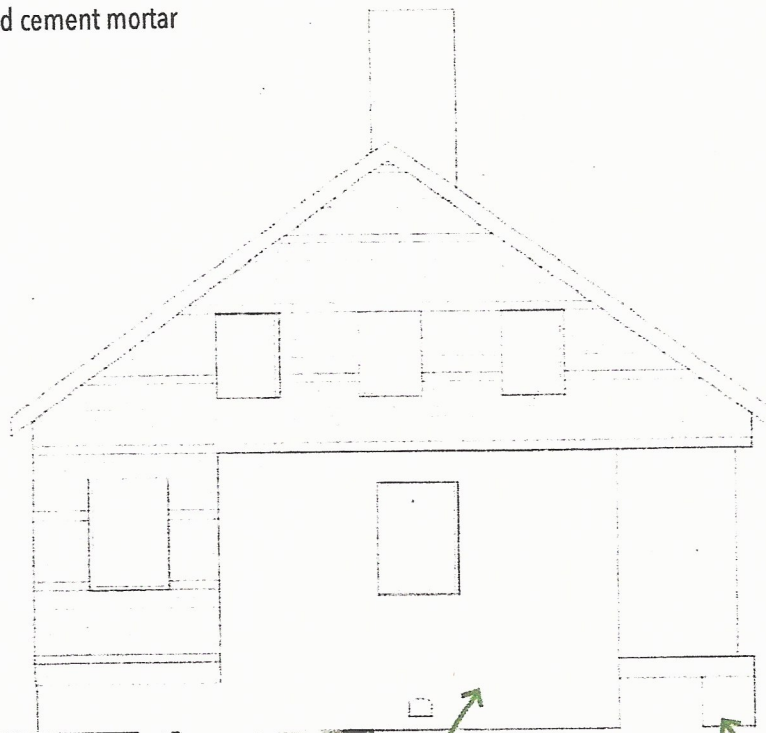
EXPOSED BRICK FOUNDATION

The Portland cement has proven to be detrimental. It has caused water to become trapped forcing a separation of stucco from the brick walls. There are numerous places where stucco loss has occurred to such an extent that the brick is entirely exposed. The exposure of the brick also reveals the mortar loss that has occurred.

In order for the site to move forward, any places where the brick is exposed should see a removal of previous portland cement and lime mortars. A 4-inch blade should be used to remove the mortars. However, if the mortar does not come off easily, it should not be forced to prevent further damage to the brick walls. Hydraulic lime mortar 2 should be used for repointing. A breathable stucco should be placed onto the exposed brick to prevent further brick damage. In places where the Portland cement remains in place, it should not be removed due to the damage that could be caused by the removal process.

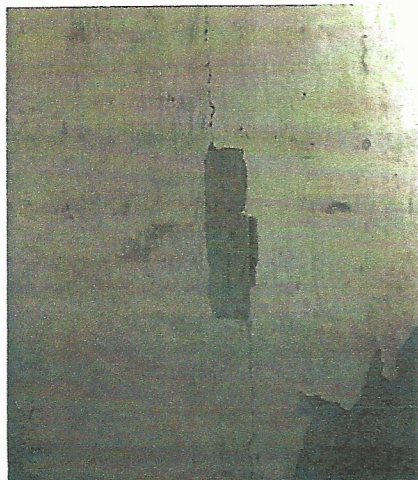
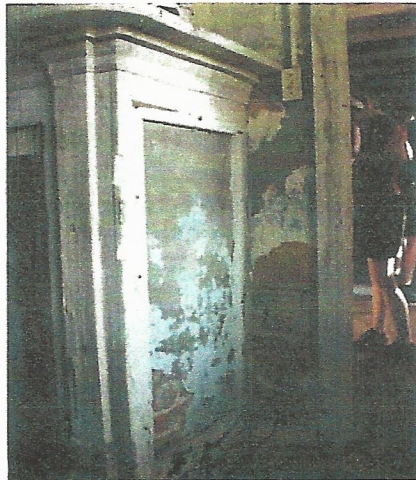
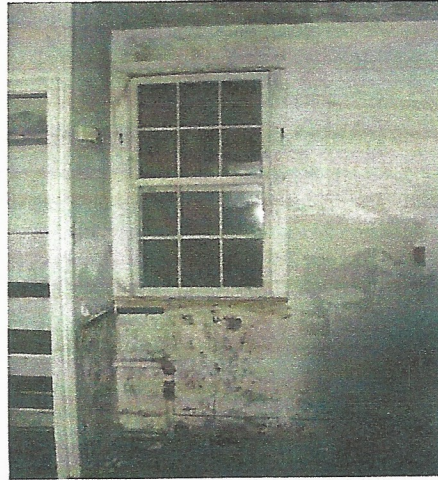
Main Room: The plaster is cracked on the north wall adjacent to the attic and chimney as well as on the south wall in line with the window. In some places the plaster is lost and exposing the brick between post wall structure. This is seen to the right and the left of the fireplace, with the post exposed on the right and the brick and mortar exposed on the left bottom section between the door and the fireplace. Portland cement was applied just above the baseboard in some sections of the wall which appears to be an effort to patch previous stucco/plaster failure. Kitchen: Much of the stucco is degraded or lost near the baseboards. Where the bricks and mortar are exposed, the mortar, which is a soft, clay based mortar is deteriorating due to rising damp. Side Room: The plaster is cracked and lost in some sections exposing the brick and mortar. The mortar is deteriorating where exposed. Some evidence of portland cement near the baseboards in some areas of the walls where surface plaster has been lost. The plaster is cracking primarily on the walls adjacent to the fireplace, which is similar to the main room.

Kitchen: The interior walls of the kitchen are drywall material. Some poorly patched areas visible. Bathroom: The ceiling of the bathroom is drywall. Ceiling is severely water damaged with large sections of loss of the drywall exposing the attic flooring and joists.

Stress cracks in the plaster can be repaired by opening the crack slightly with a crack widener and filled with a layer of joint compound and then adhering fiberglass mesh tape to close gap followed by another layer joint compound. Where there are large sections of plaster/stucco missing it will be necessary to repair the holes by filling them in with the appropriate lime/plaster replacement material.

The walls in the kitchen can be replaced due to unsightly patches of the existing walls. The bathroom ceiling should be totally removed and the source of the water damage identified. Once this is sourced it should be addressed first. Once addressed, an appropriate ceiling can be installed.

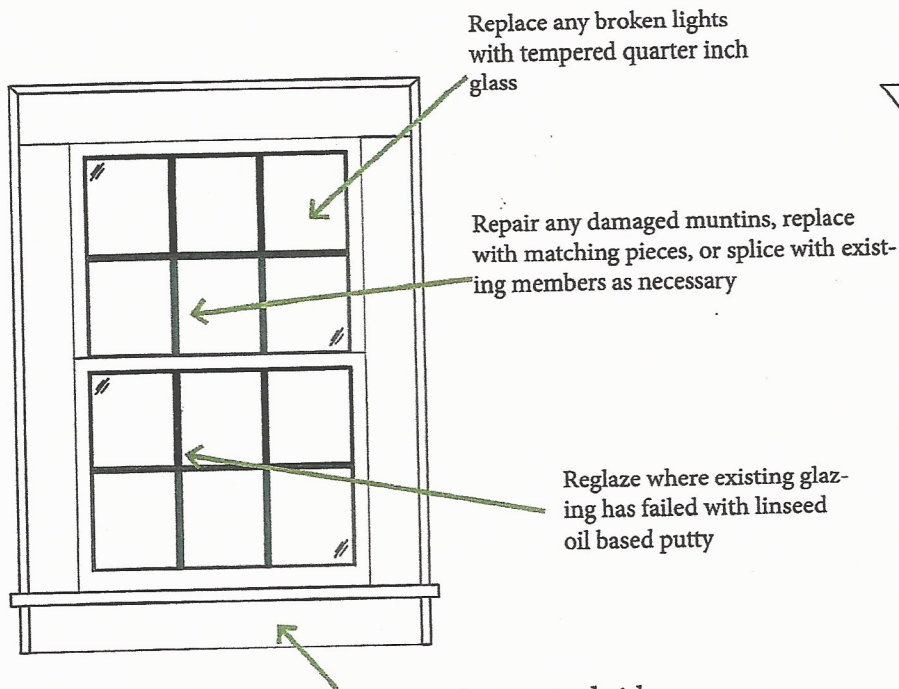
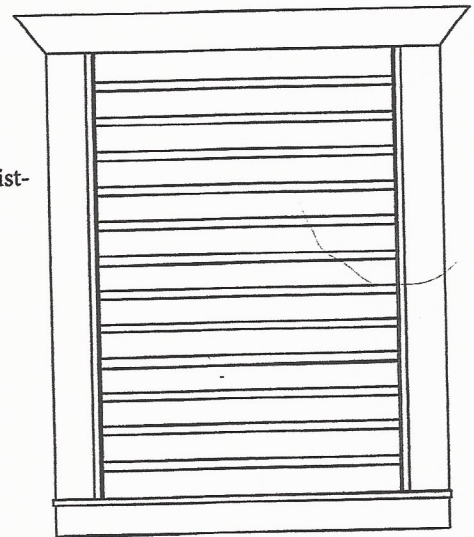
The window in the side room is in disrepair with severely degraded or missing glazing compound. The windows in the other rooms are in relatively good condition with limited damage such as cracked glass and damaged muntins.

The windows should be restored according to the National Park's Secretary of the Interior's Preservation Briefs. Determine what level of intervention each window will need based on the level of deterioration. Each one will need routine maintenance as outlined in the briefs but may also require stabilization or splices and parts replacement for damaged muntins or broken panes of glass.

Rotten or damaged wood sections can be repaired either through dutchman repairs or through a combination of semirigid consolidant and epoxy to build up surface. Once sanded this can then be primed and painted.
